# **NASA CONTRACTOR REPORT 181965**

## **FRACTOGRAPHY OF COMPOSITE DELAMINATION**

**W. D. Bascom**  
University of Utah  
Salt Lake City, Utah

**July 1990**  
Grant NAG1-705

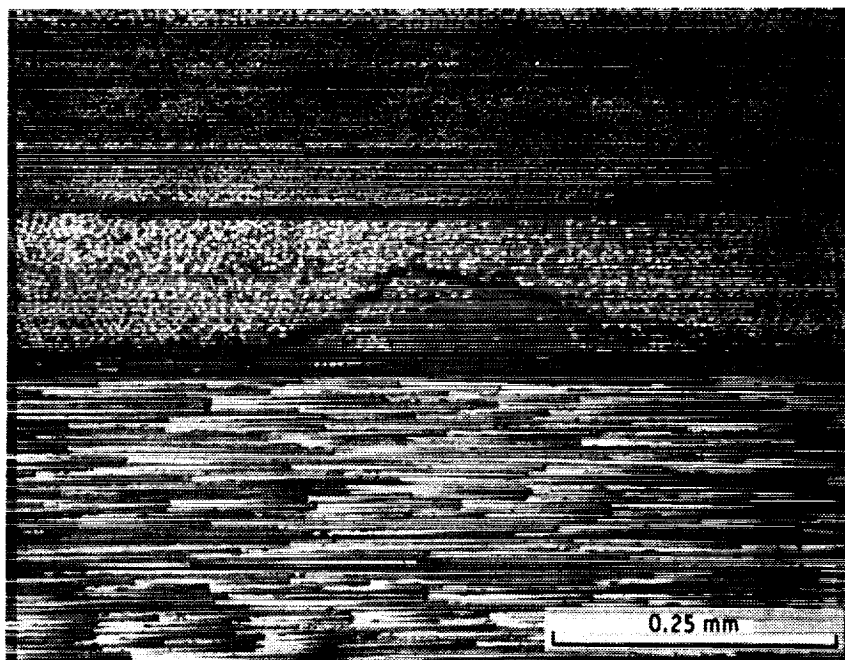
Contrary to expectations, the Mode II crack did not propagate through the resin rich regions between plies in the cross-ply laminates. Instead, propagation was solely within the  $0^\circ$  plies near the boundary with the resin layer. This phenomena was encountered in a study of impact damage (6) as shown in Fig. 14. The explanation offered in reference 6 is that there are residual thermal stresses near the ply-resin boundary that make propagation within this boundary more energetically favorable than propagation in the resin layer.

Figure 14 - Delamination produced by impact showing preferential propagation along the fiber/matrix boundary (reference 6).

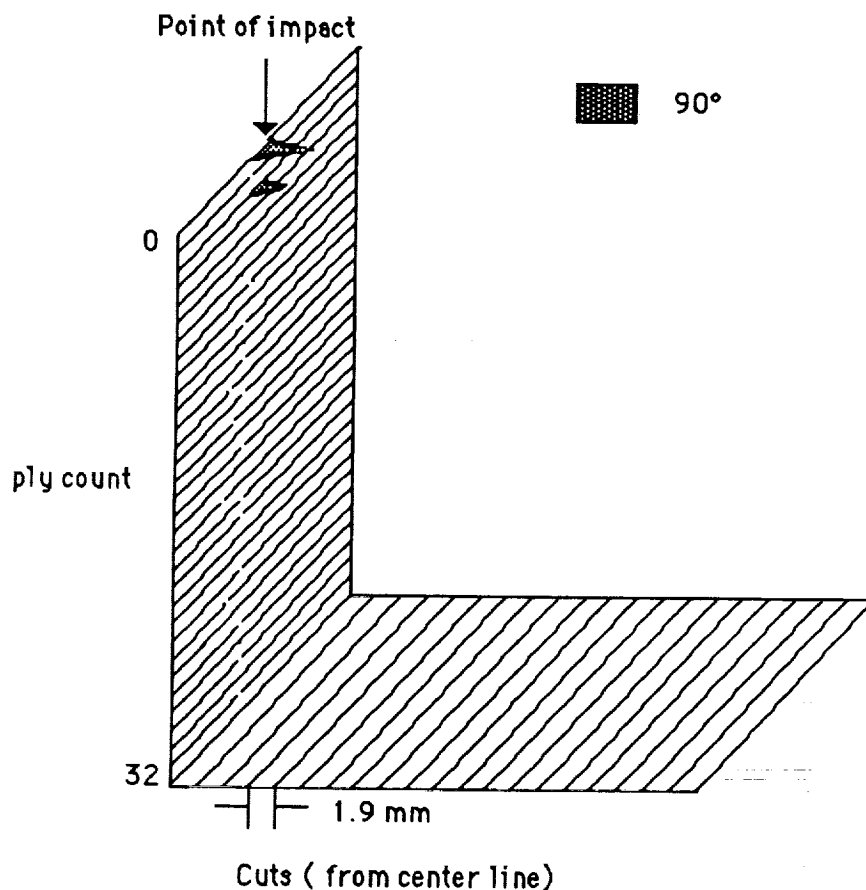
Figure 22 - Damage map of AS4/3501-6, (0/90)<sub>16s</sub> after  $\Sigma$  I.E. = 10J.

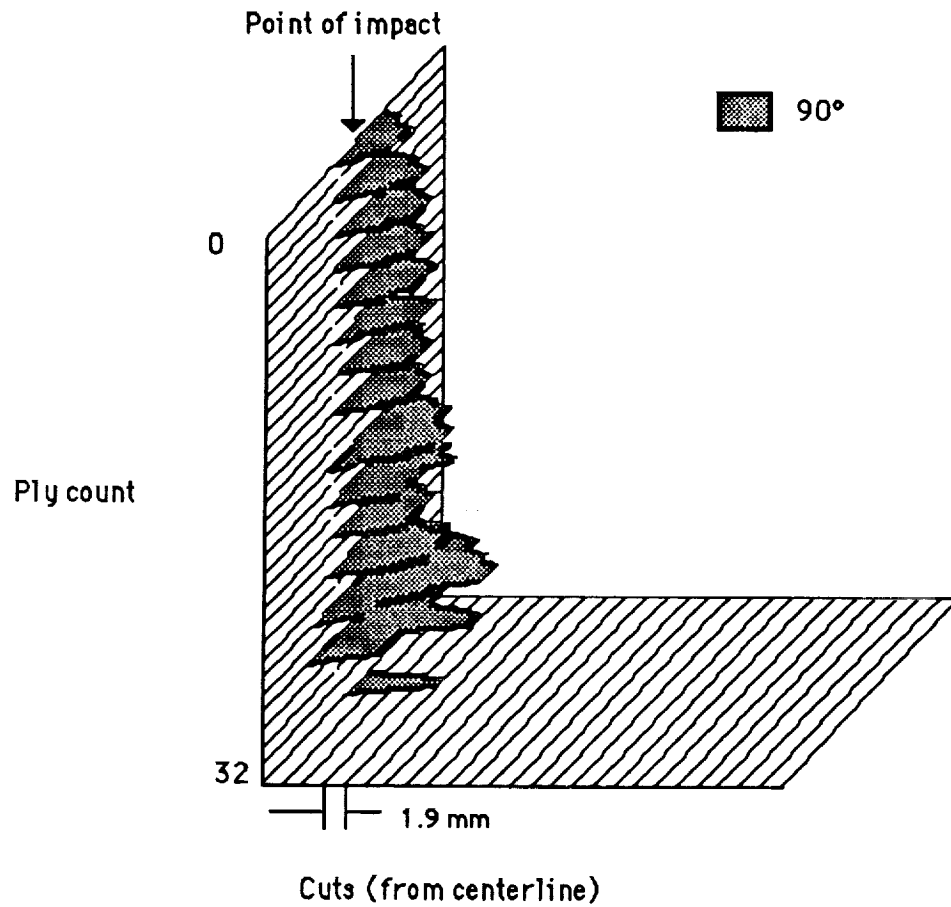
Figure 23 - Damage map of AS4/3501-6, (0/90)<sub>16s</sub> after  $\Sigma$  I.E. = 80J.

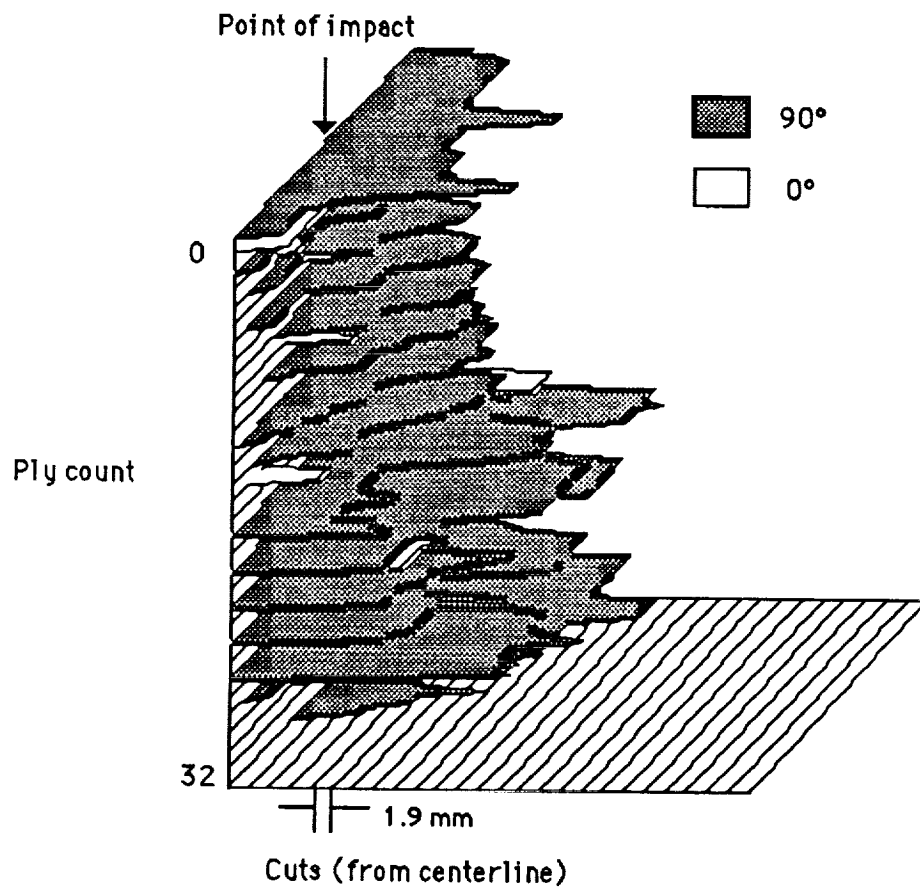
In the third stage, the damage had propagated to the edges of the sample (Fig. 21c) and fiber breakage was observed (Fig. 25b).

Figure 24 - Damage map of AS4/3501-6, (0/90)<sub>16s</sub> after  $\Sigma$  I.E. = 170J.

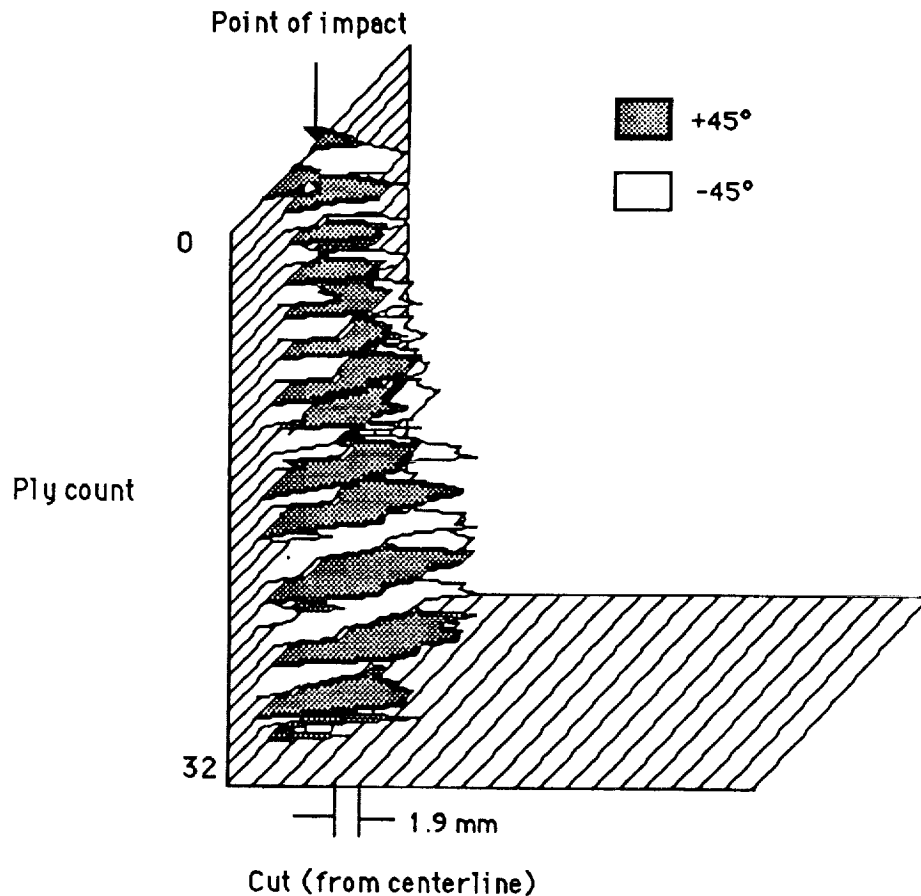
Figure 28 - Damage map of AS4/3501-6, (±45)<sub>16s</sub> after  $\Sigma$  I.E. = 80J.

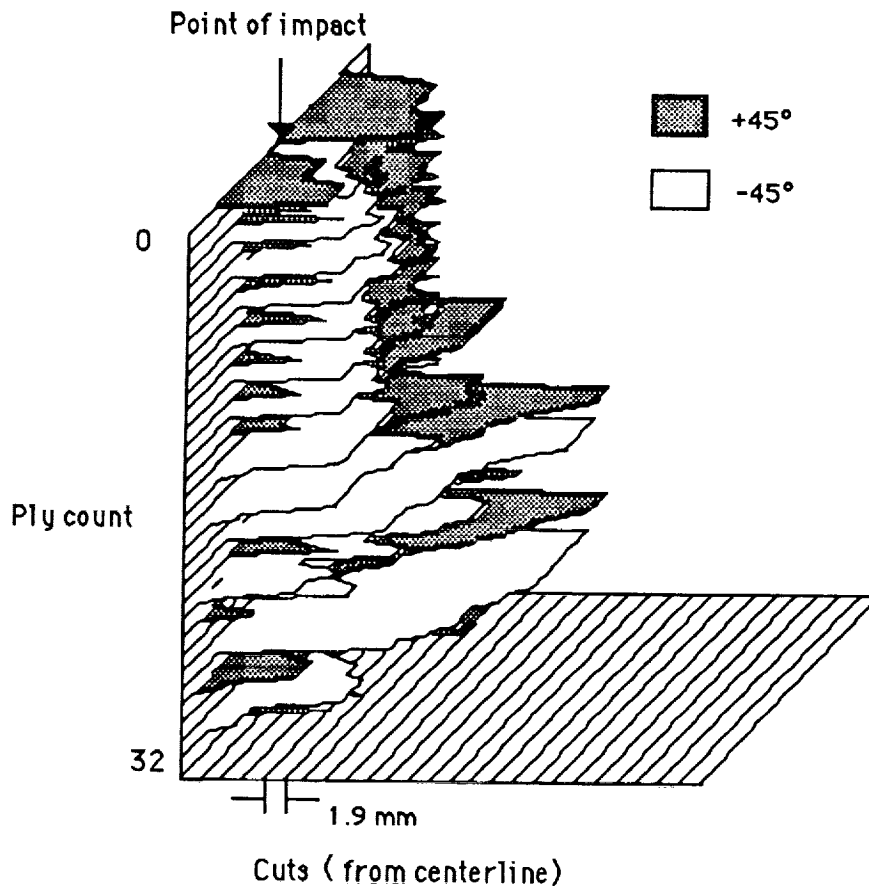
The second stage in the stiffness plot extended to higher cumulative impact energies and the third stage was not as clearly defined compared to the (0/90) laminate. The second stage corresponded to through the thickness damage as shown by the damage map in Fig 28. This damage extended to the edges of the laminate after a  $\Sigma$  I. E. of 300 J (Fig. 29)

Figure 29 - Damage map of AS4/3501-6,  $(\pm 45)_{16s}$  after  $\Sigma$  I.E. = 310J.

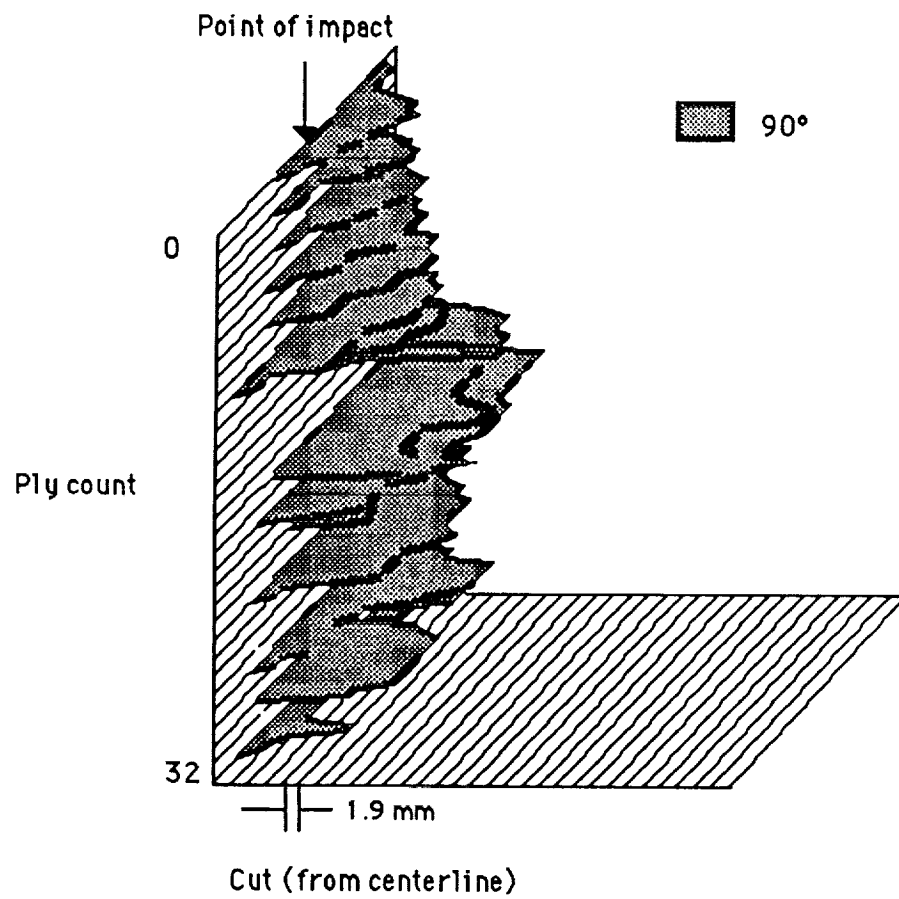
Figure 32 - Damage map of IM6/3501-6, (0/90)<sub>16s</sub> after  $\Sigma$  I.E. = 110J.

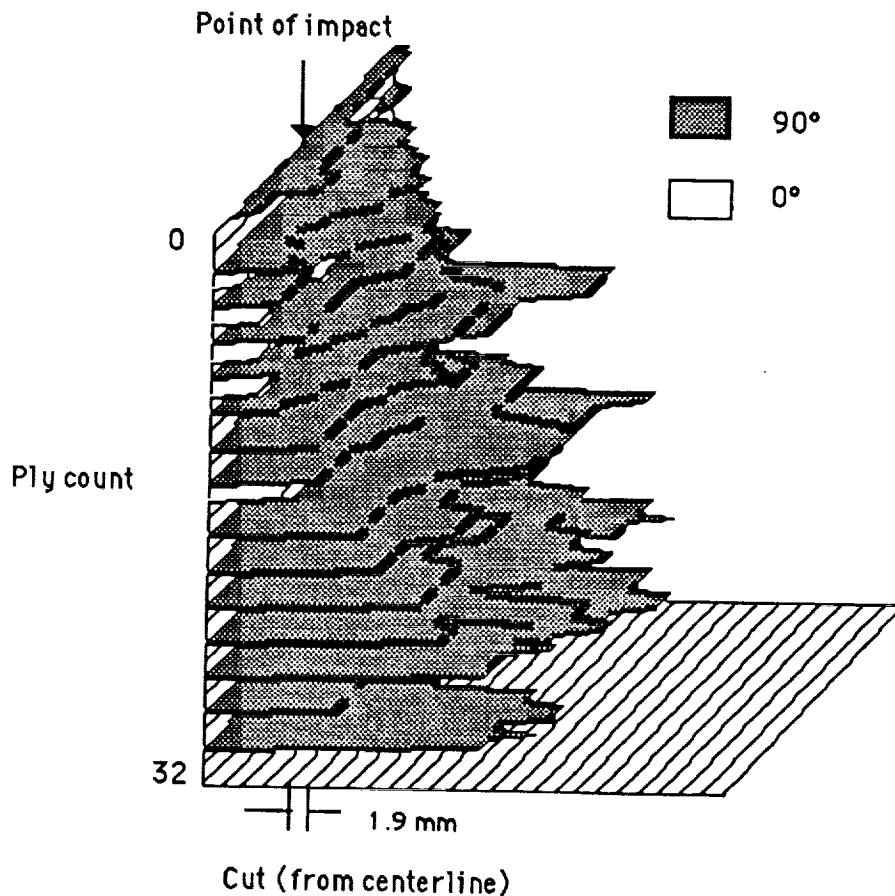
Figure 33 - Damage map of IM6/3501-6, (0/90)<sub>16s</sub> after  $\Sigma$  I.E. = 190J.

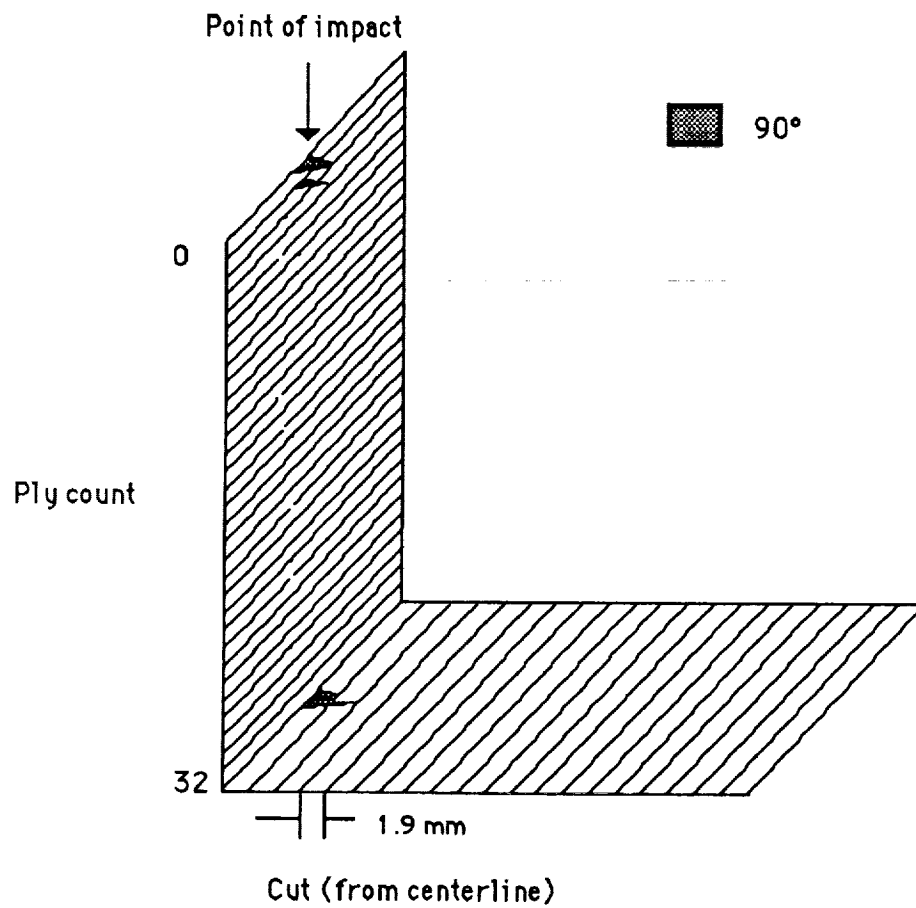
Figure 37 - Damage map of AS4/PEEK, (0/90)<sub>16s</sub> after  $\Sigma$  I.E. = 35J.

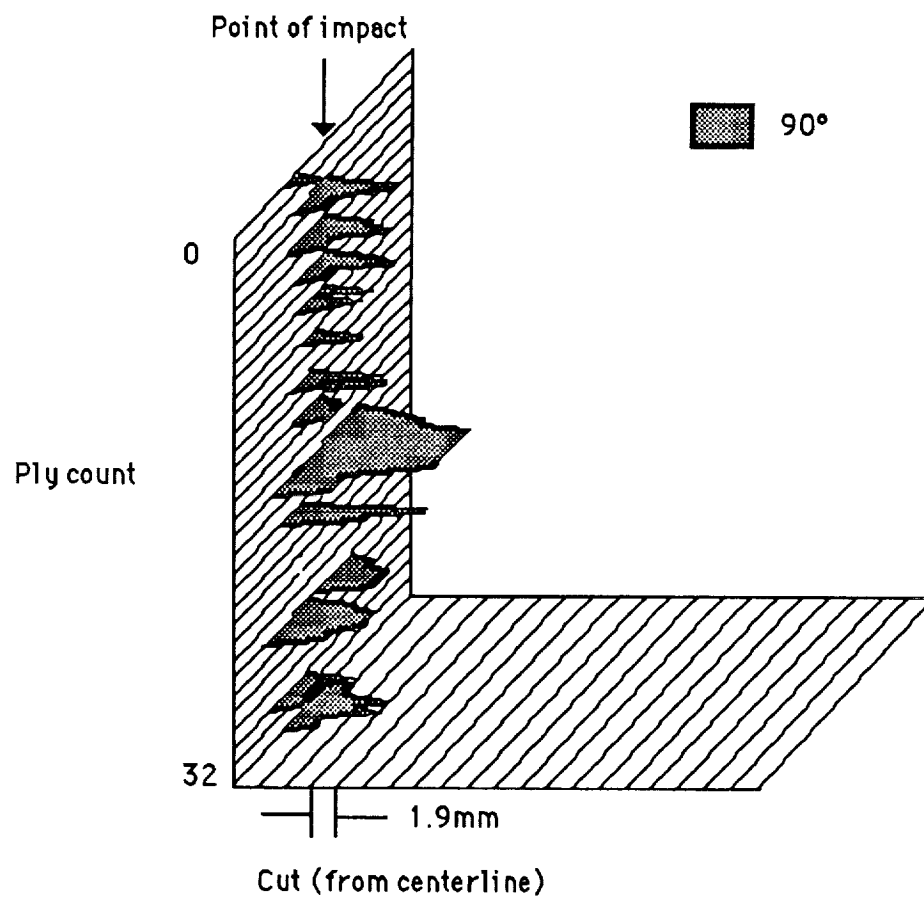
Figure 38 - Damage map of AS4/PEEK, (0/90)<sub>16s</sub> after  $\Sigma$  I.E. = 115J.

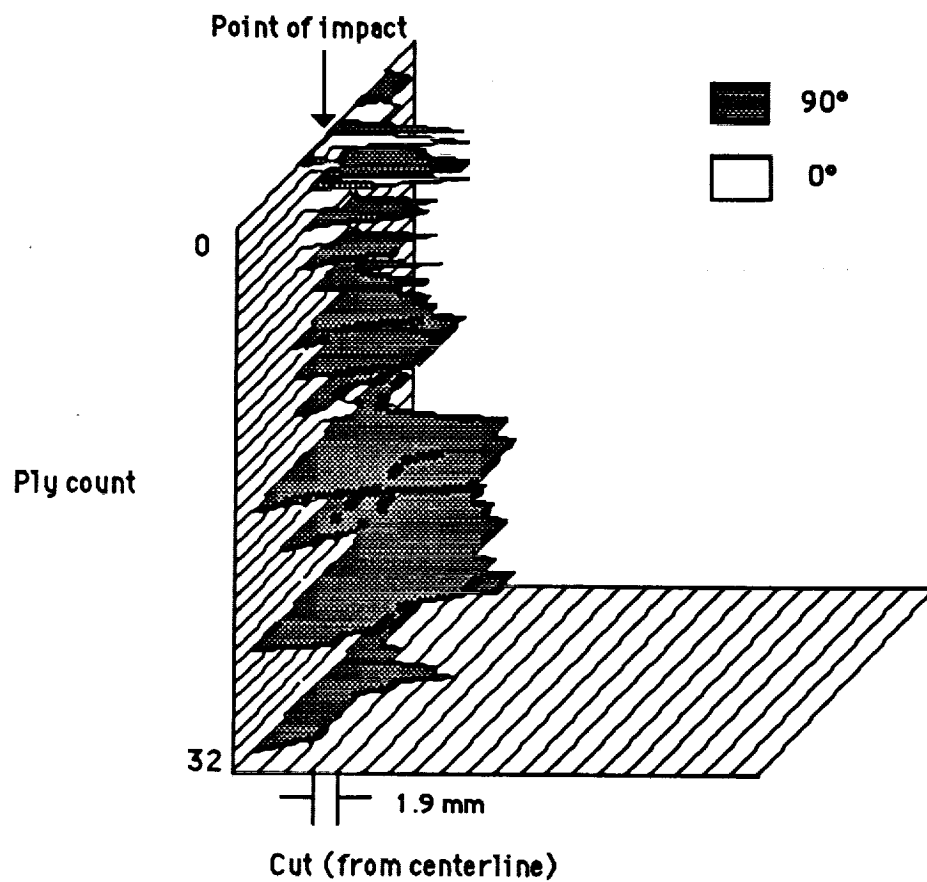
Figure 39 - Damage map of AS4/PEEK, (0/90)<sub>16s</sub> at  $\Sigma$  I.E. = 280 J

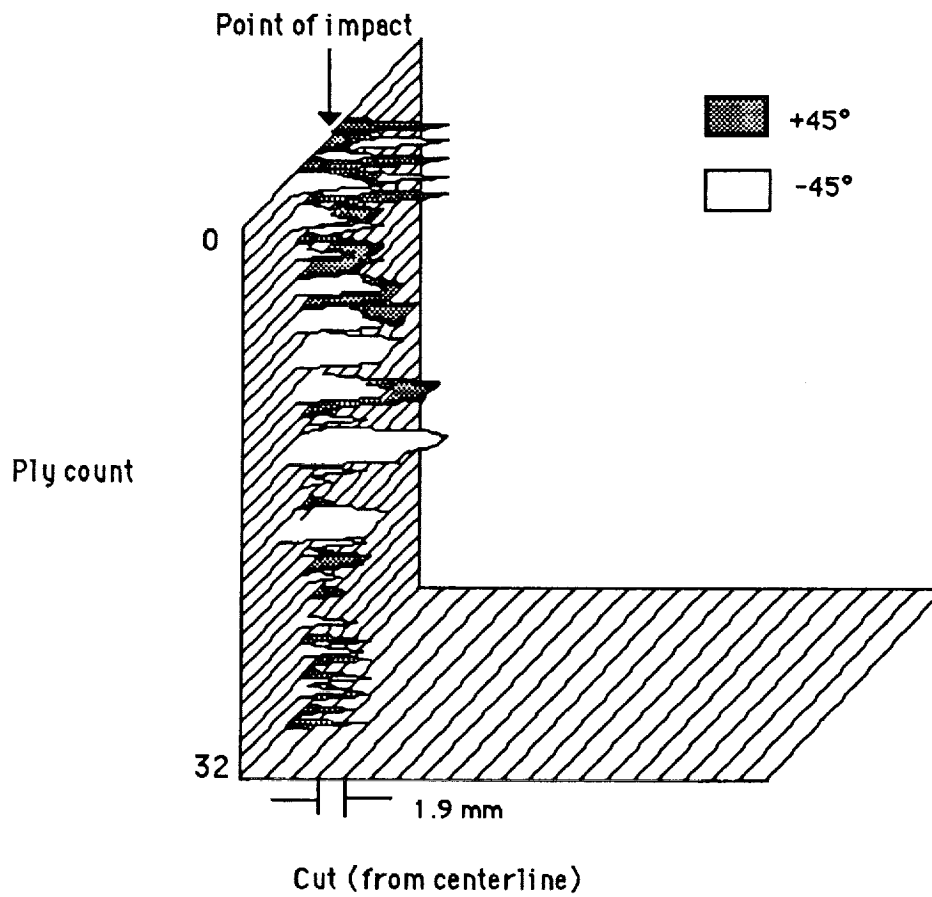
Figure 45 - Damage map of AS4/PEEK, ( $\pm 45$ ) at  $\Sigma$  I.E. = 240J

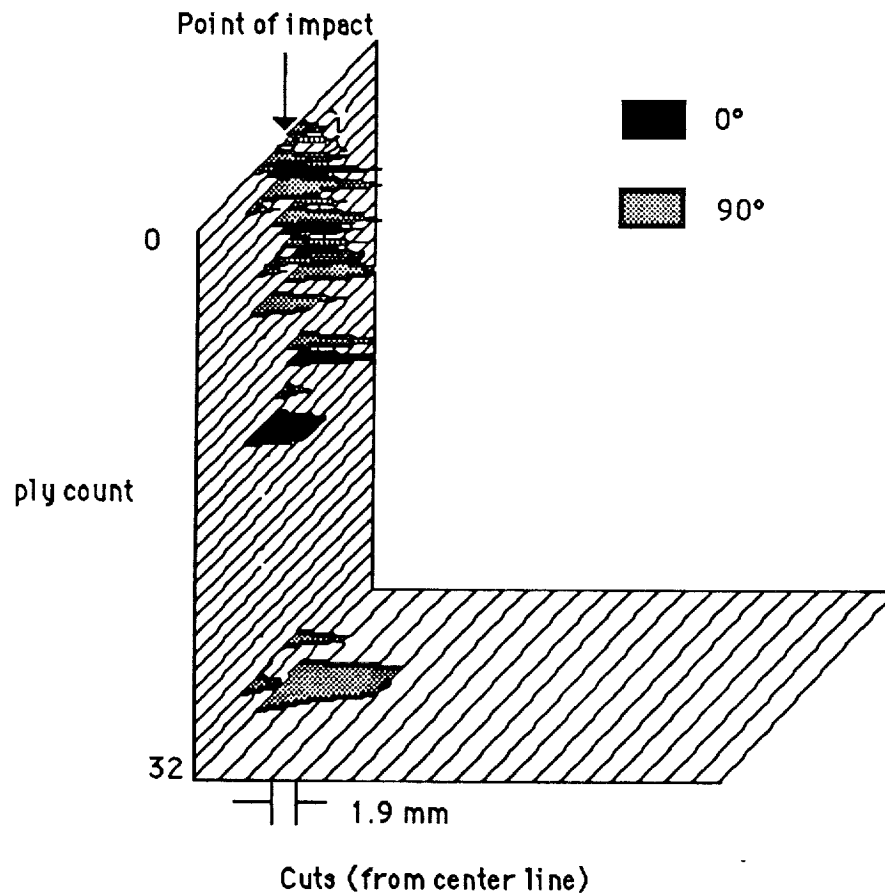
Figure 48 - Damage map of AS4/polycarbonate, (0/90)<sub>16s</sub> at  $\Sigma$  I. E. = 270J

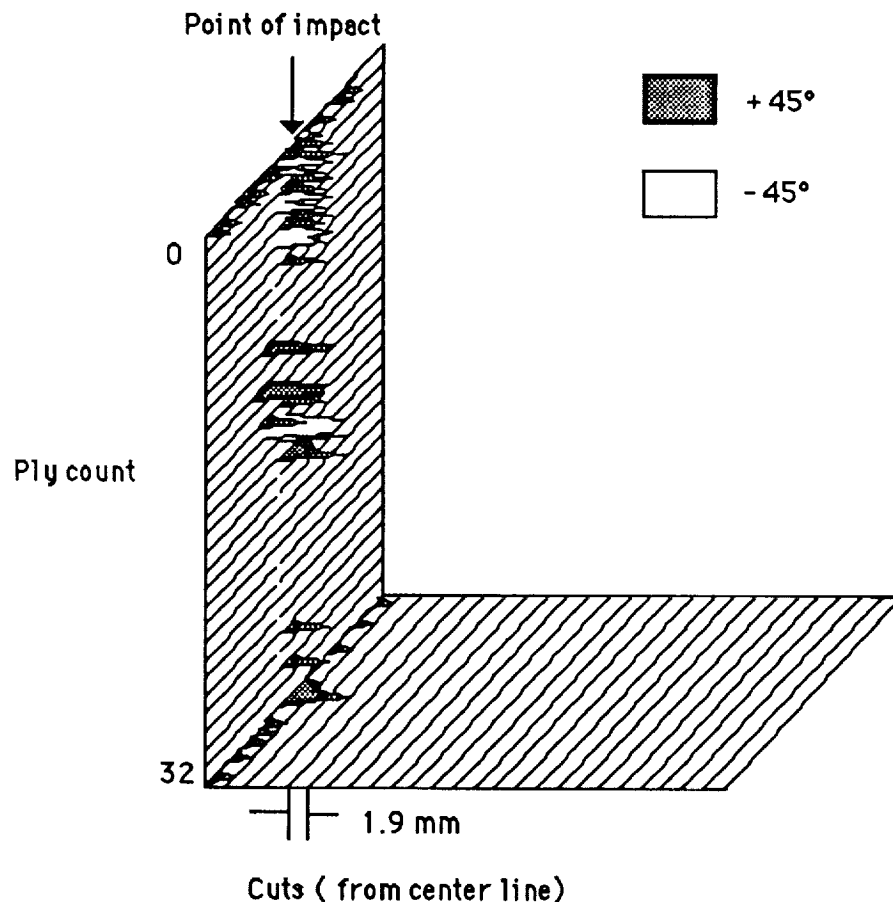
Figure 50 - Damage map for AS4/polycarbonate, ( $\pm 45$ ) at  $\Sigma$  I.E. = 250J

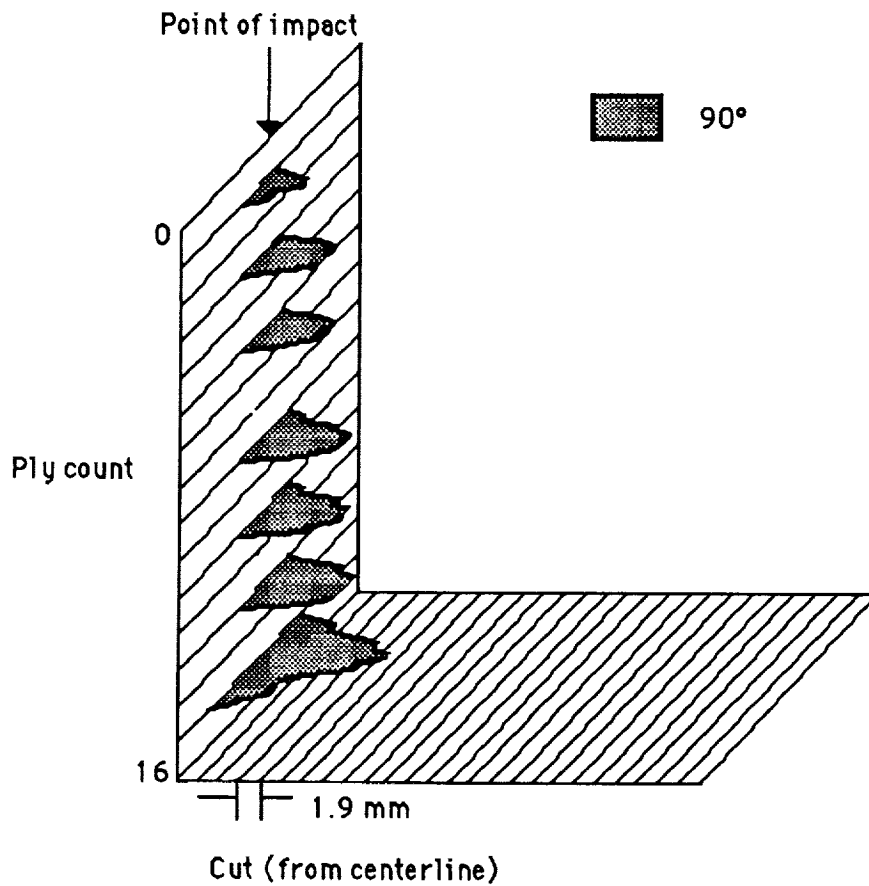
Figure 54 - Damage map for AS4/3501-6 (0/90)<sub>8s</sub> at  $\Sigma$  I. E. = 10J

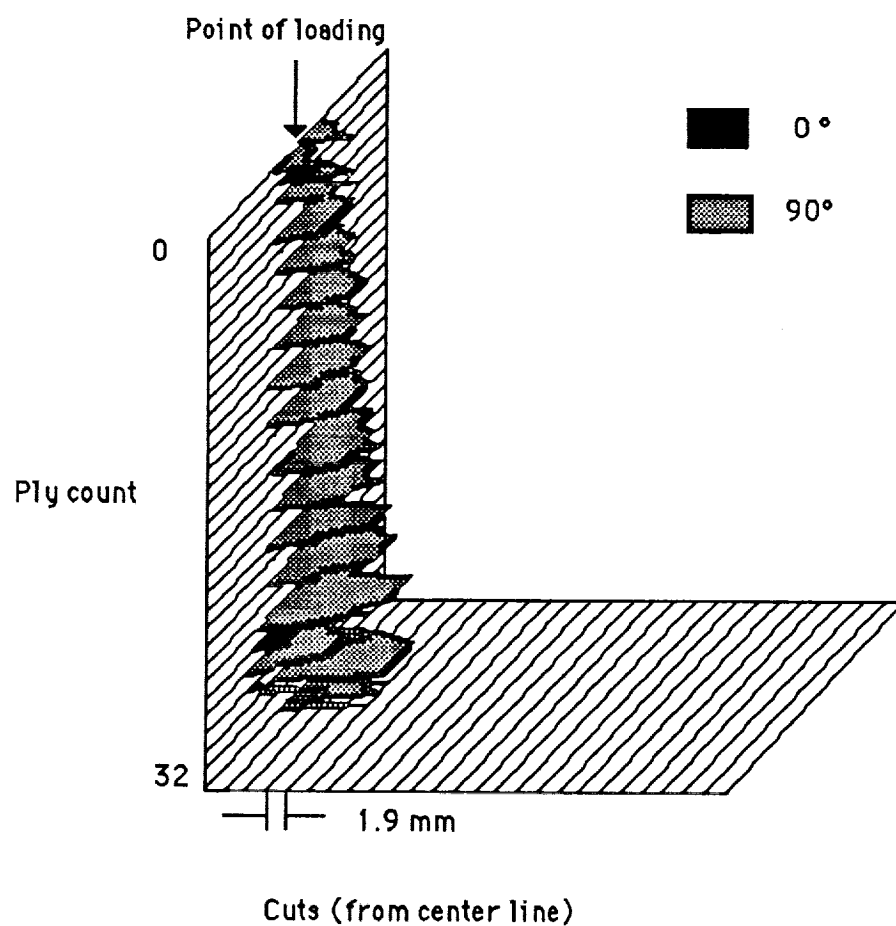
Figure 61 - Damage map of AS4/3501-6,(90/0)<sub>16s</sub> laminate loaded to a displacement of ~3mm

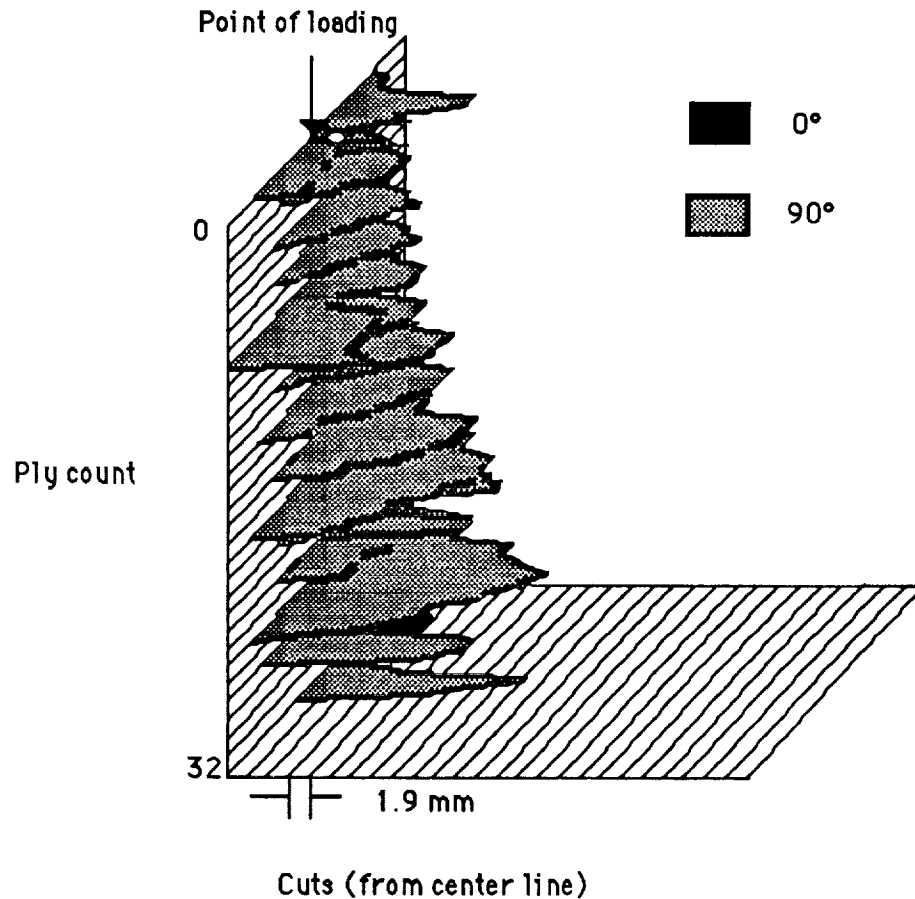
Figure 62 - Damage map of AS4/3501-6,(90/0)<sub>16s</sub> laminate loaded to a displacement of ~ 4 mm

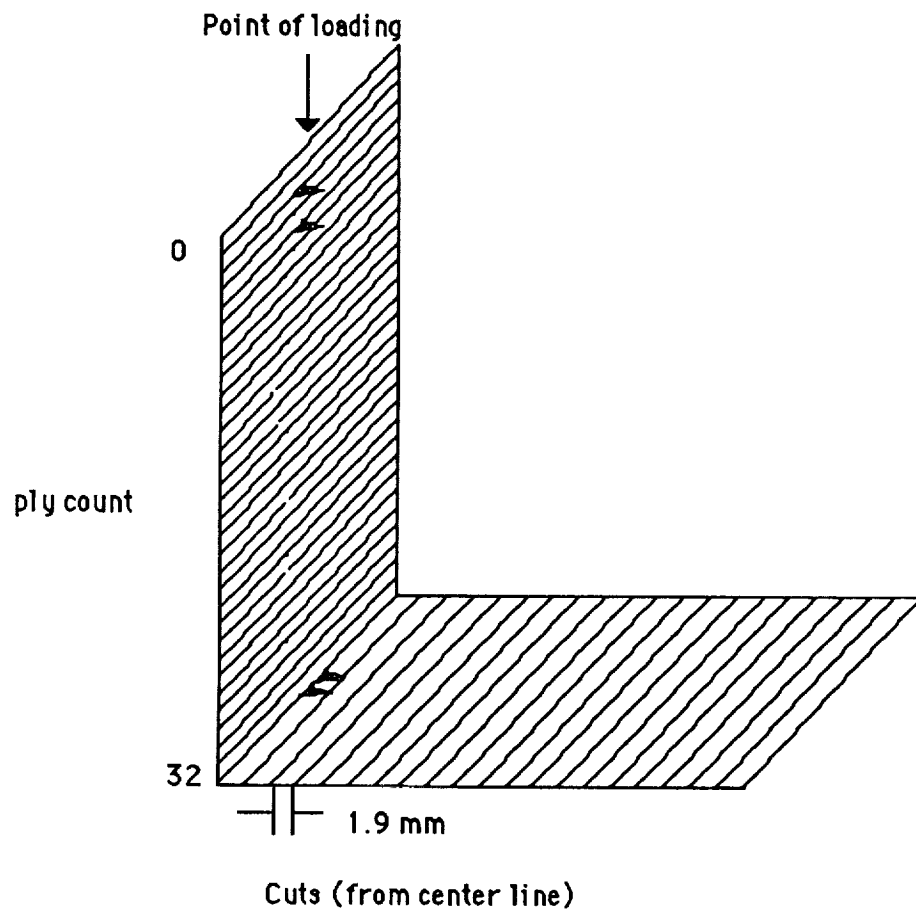
Figure 67 - Damage map for an AS4/PEEK,(90/0)<sub>16s</sub> laminate loaded to about 4mm displacement

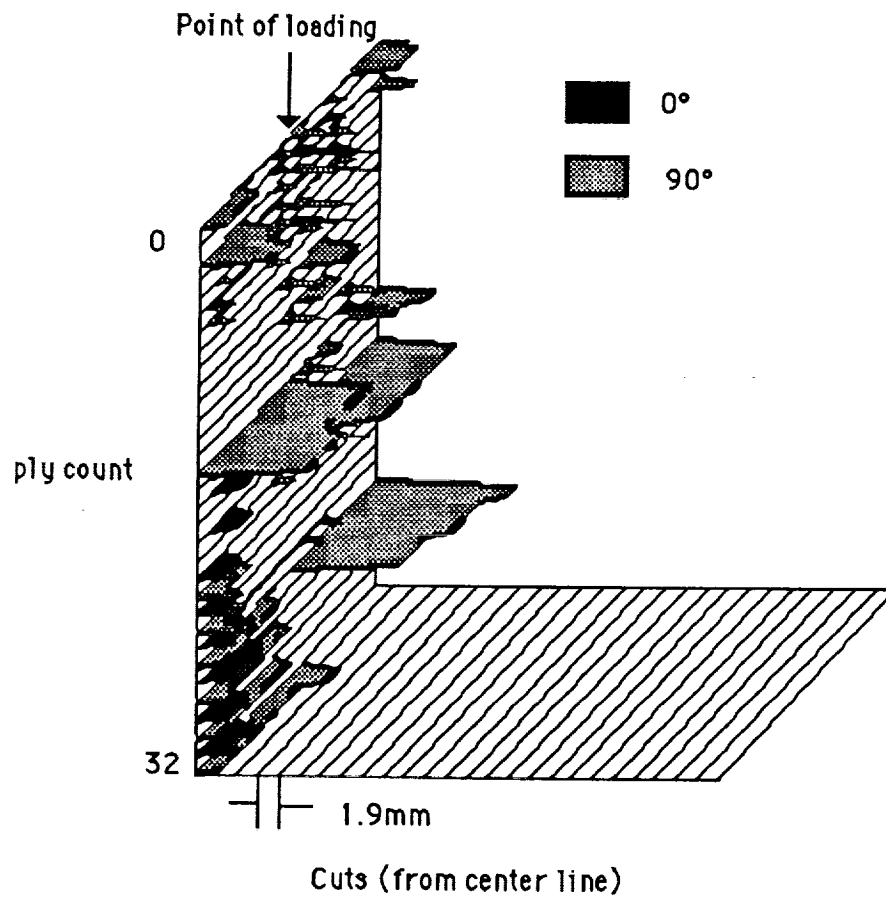
Figure 68 - Damage map for an AS4/PEEK,(90/0)<sub>16s</sub> laminate loaded to about 5.5mm displacement

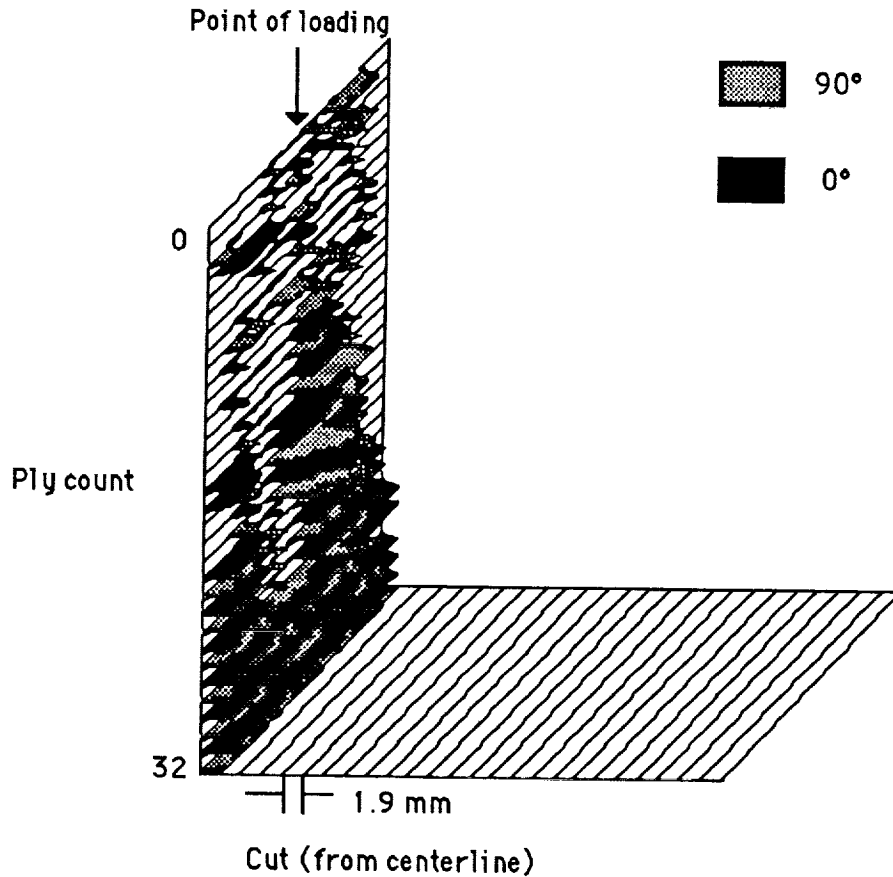
Figure 73 - Damage map of AS4/polycarbonate(0/90)<sub>16s</sub> after 4.5mm displacement
